**Flood Control Project Maintenance
Levee Inspections**

Fall 2008 Levee Maintenance Deficiency Summary Report

San Joaquin River Basin

Reclamation District No. 0404

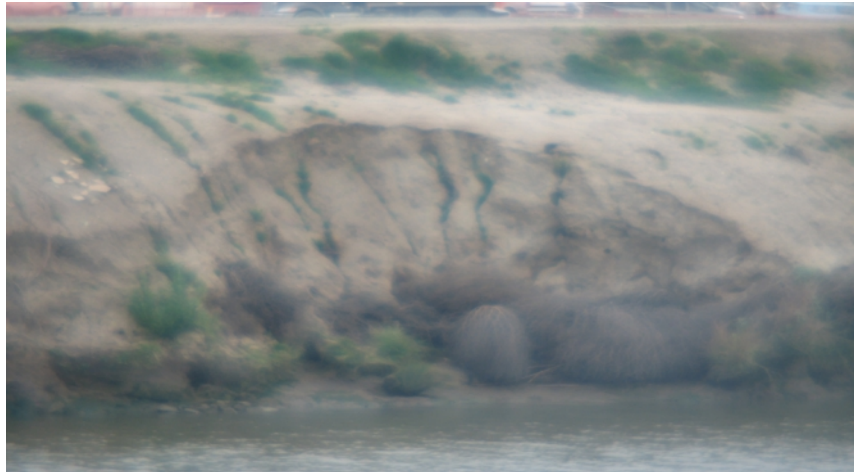
Levee Mile Report Line	2
Start Levee Mile	0.24
End Levee Mile	0.27
Location	
Category	Earthen Levee
Item	Erosion / Bank Caving
Erosion from LM 0.24 to 0.27

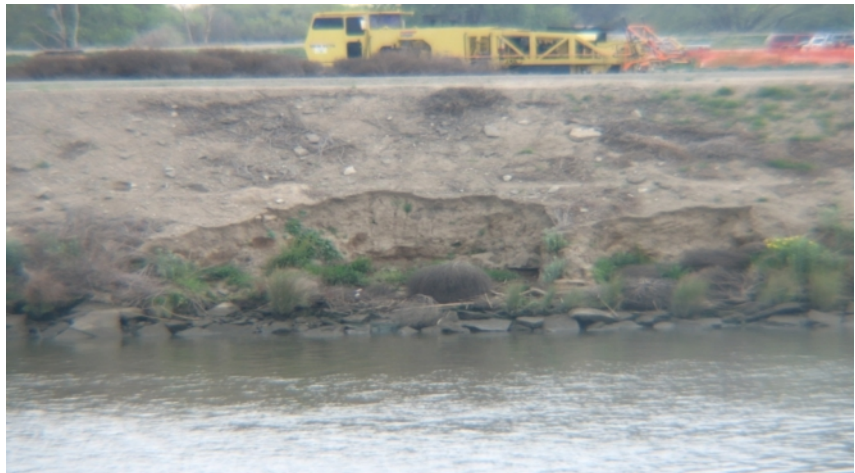
Levee Mile Report Line	2
Start Levee Mile	0.24
End Levee Mile	0.27
Location	
Category	Earthen Levee
Item	Erosion / Bank Caving
Erosion at LM 0.27

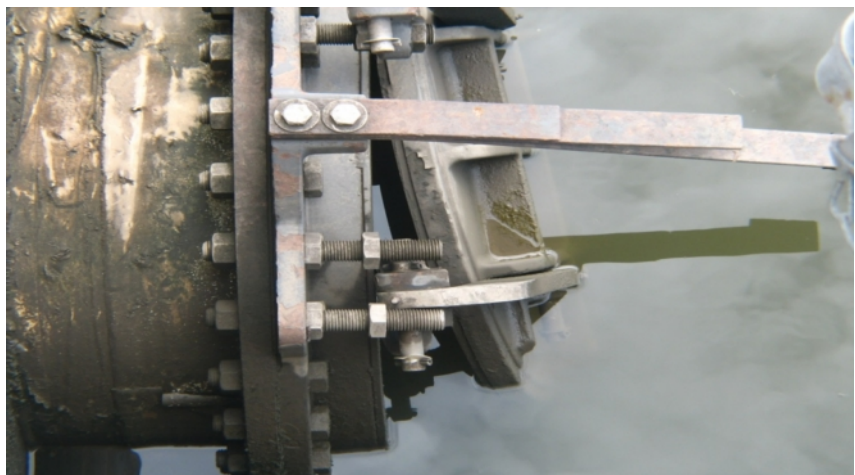
Levee Mile Report Line	12
Start Levee Mile	1.80
End Levee Mile	1.80
Location	
Category	Interior Drainage & Piping Systems
Item	Flap Gates
Flap gate at City of Stockton Pump Station LM 1.80 right hinge broken

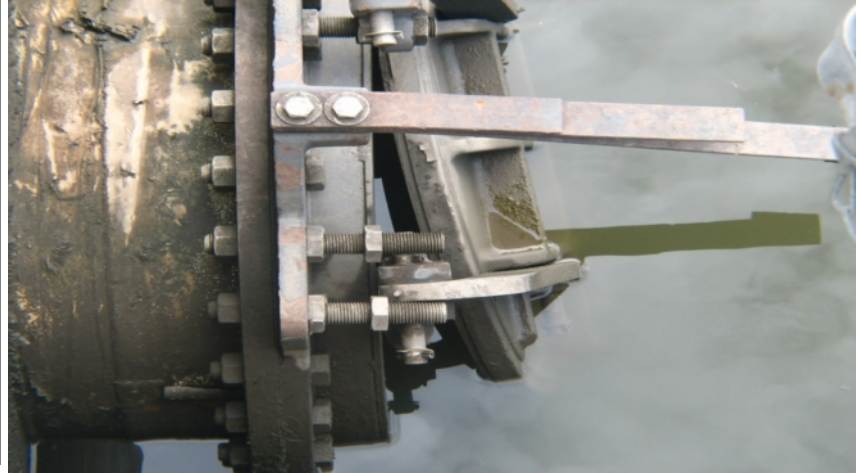
Levee Mile Report Line	12
Start Levee Mile	1.80
End Levee Mile	1.80
Location	
Category	Interior Drainage & Piping Systems
Item	Flap Gates
Flap gate at City of Stockton Pump Station LM 1.80 right hinge broken

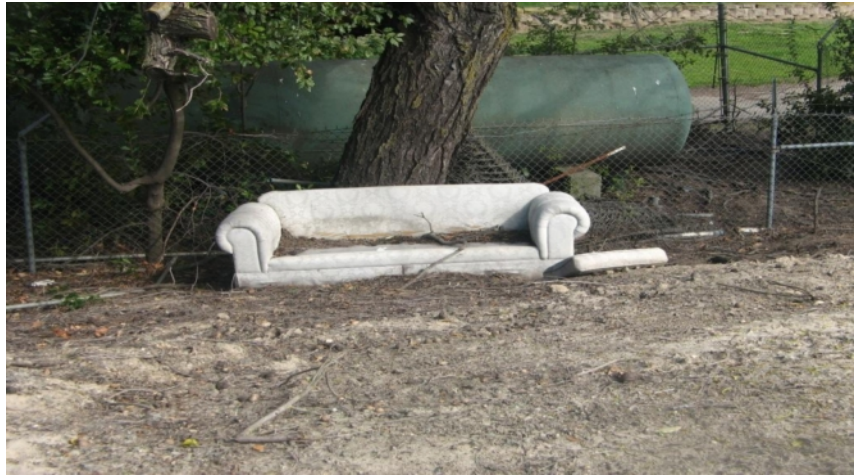
Levee Mile Report Line	6
Start Levee Mile	1.13
End Levee Mile	1.13
Location	
Category	Earthen Levee
Item	Encroachments
Sofa at landside toe LM 1.13

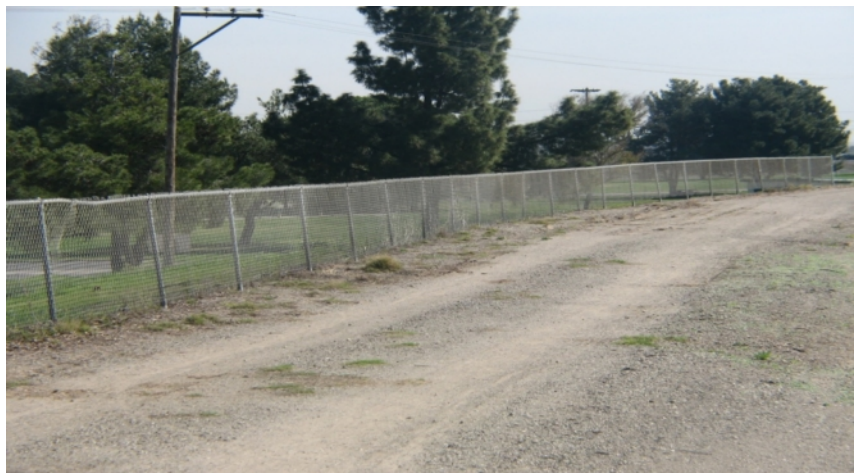
Levee Mile Report Line	9
Start Levee Mile	1.47
End Levee Mile	1.52
Location	
Category	Earthen Levee
Item	Encroachments
Fence at landside shoulder from LM 1.47 to 1.52
